## 測試報告 Test Report

號碼(No.) : CE/2019/74624    日期(Date) : 2019/07/30    頁數(Page) : 1 of 4

送樣廠商(Sample Submitted By) : 嘉博貿易股份有限公司 (INTERTRUST CORPORATION)  
樣品名稱(Sample Description) : PUFF DINO LONG-LASTING ANTI-RUST (恐龍長效防鏽劑)  
樣品型號(Style/Item No.) : DI74  
收件日期(Sample Receiving Date) : 2019/07/24  
測試期間(Testing Period) : 2019/07/24 to 2019/07/30

=====  
測試需求(Test Requested) : 依據客戶指定，於送測樣品中檢測鹵素-氟、氯、溴、碘含量。(As specified by client, to test Halogen-Fluorine, Chlorine, Bromine, Iodine in the submitted sample.)

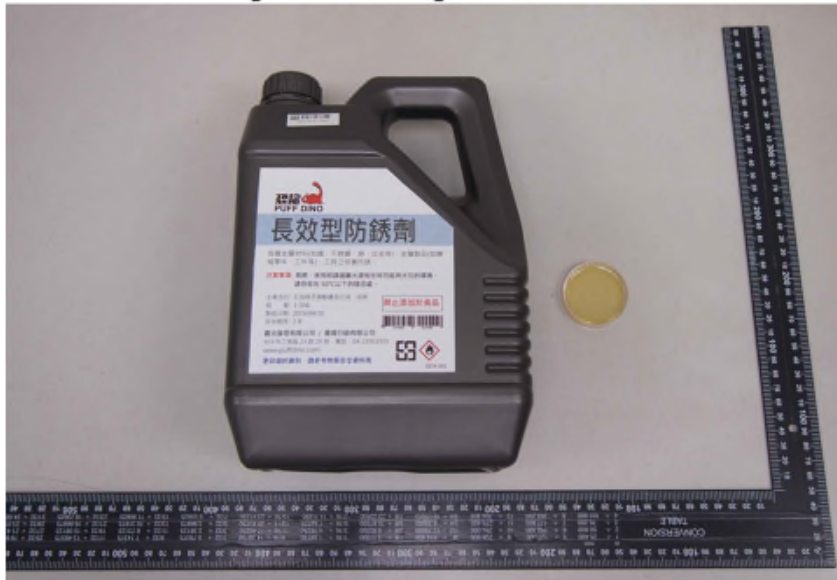
### CE/2019/74624

\* 照片中如有箭頭標示，則表示為實際檢測之樣品/部位。  
(The tested sample / part is marked by an arrow if it's shown on the photo.)
